### **CUSTOMIZED CUP IMPLANT WITHOUT REMOVING THE FEMORAL STEM FOR A COMPLEX HIP PROSTHESIS REVISION (THE THIRD) WITH MIGRATION OF THE ACETABULAR IMPLANT IN THE PELVIS**

Hospital: Clinique du Parc, Castelnau-le-Lez (France)

Surgeon: Dr. Olivier FONTES

Date: September 2024

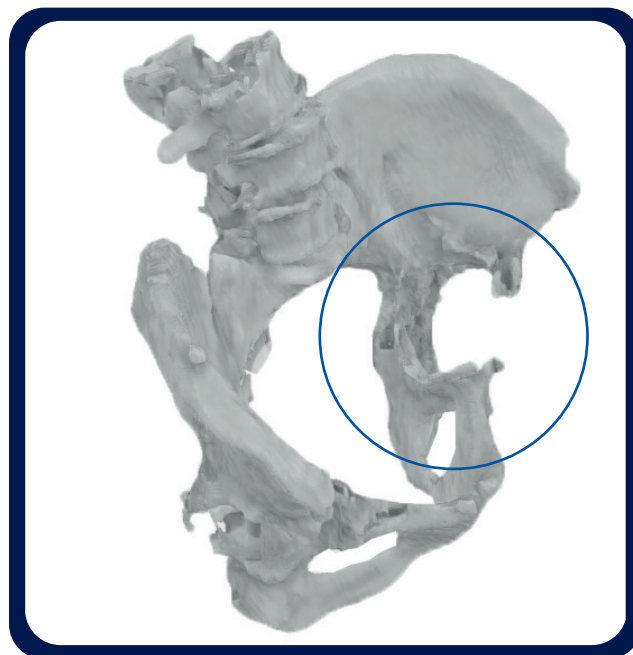
Pre-operative planning with bone defect: the challenge was to reconstruct the acetabulum and find out how to securely anchor a prosthetic acetabulum into this destroyed acetabulum

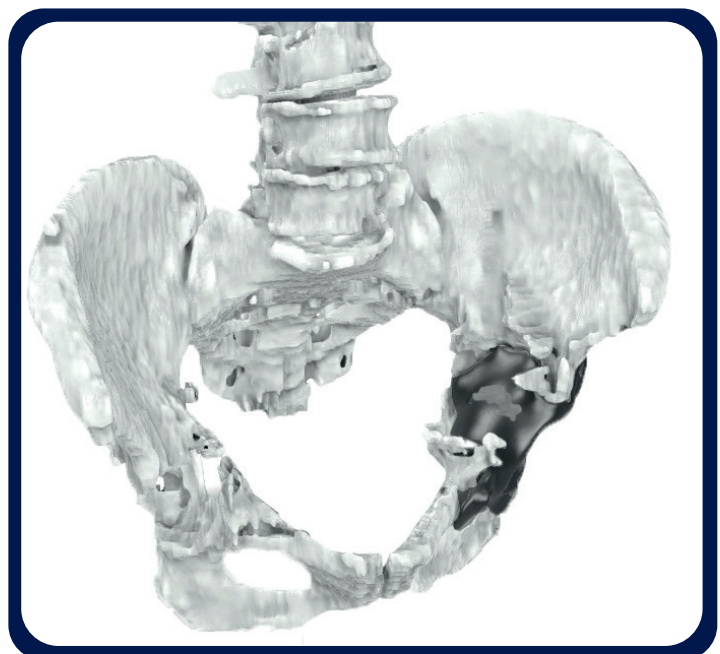
Bone defect reconstruction: the safest option in the short to medium term is the Customized acetabulum with solid anchorage in the upper and posterior part combined with an allograft filling in the anterior and posterior part.

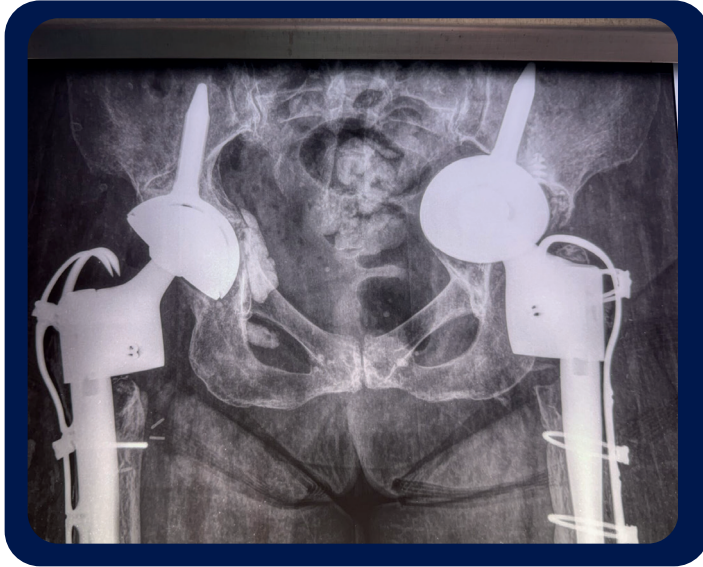
Pre-op XRAY of migrated cup into the pelvis.

A vascular evaluation was requested and a CT angiography localized the external iliac artery.

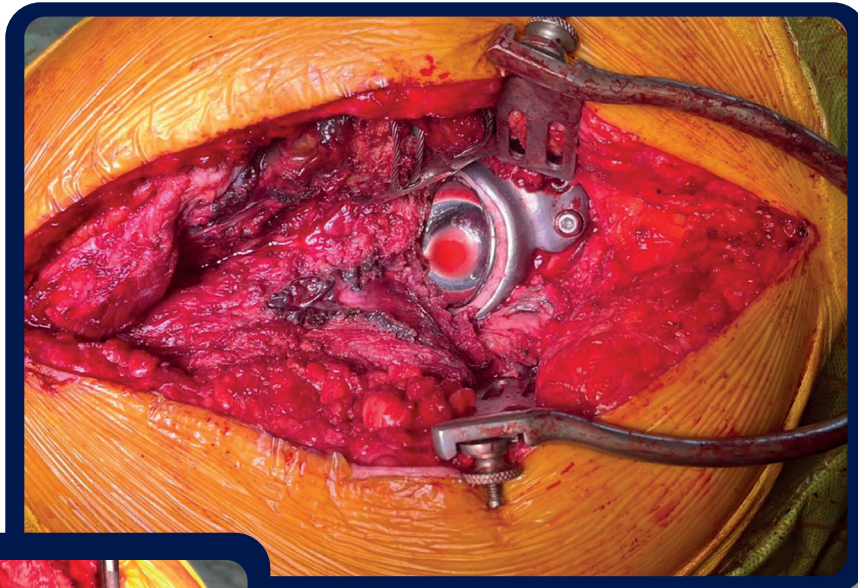
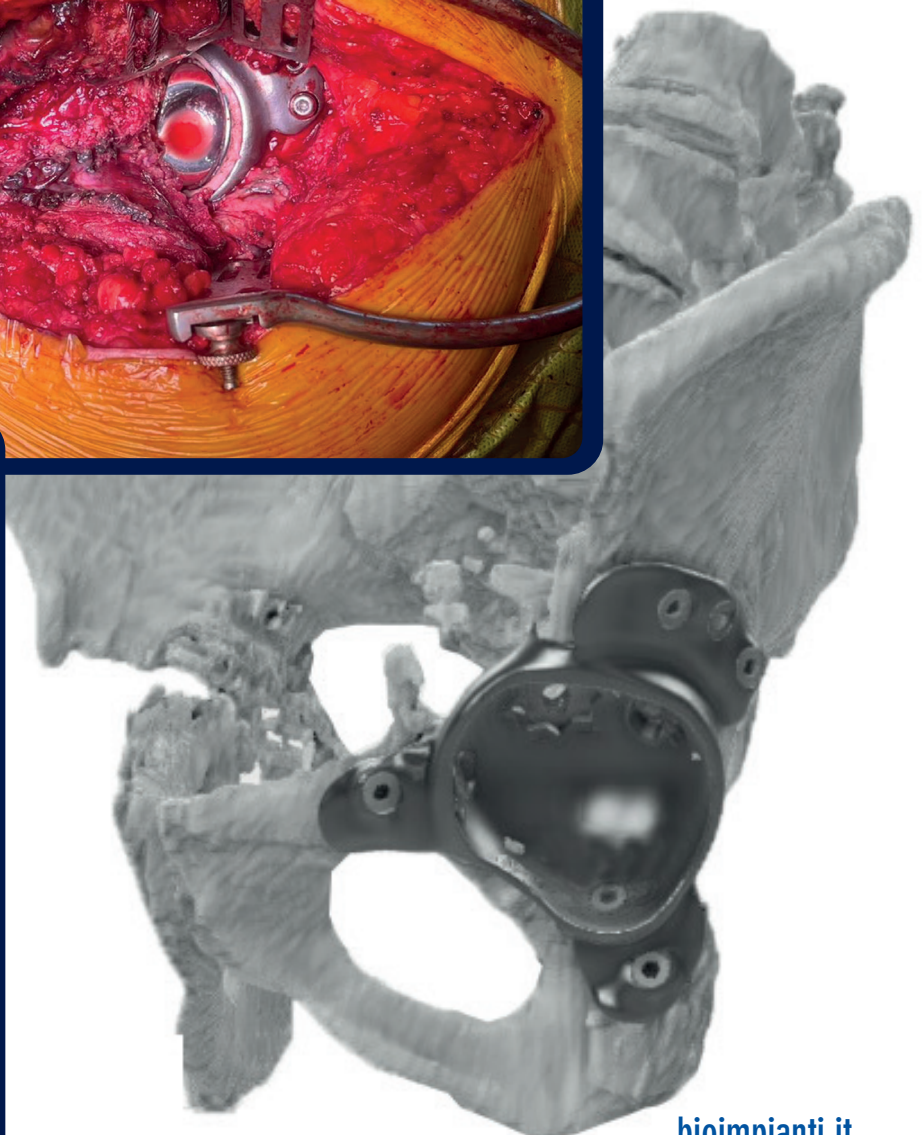
Once extracted the failed implant, the damage in the back and front was very significant:

- the top and the back of the acetabulum has been reamed
- allograft have been implanted anteriorly
- CustoMized implant has been positioned and implanted without any problem

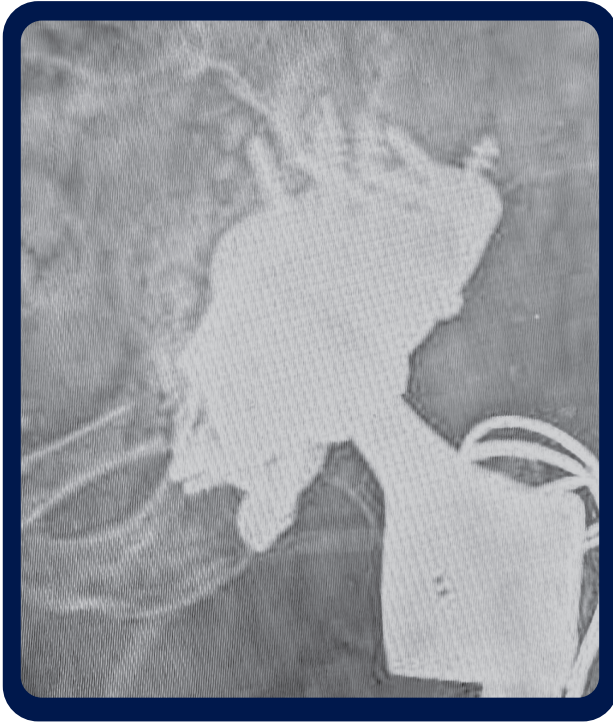
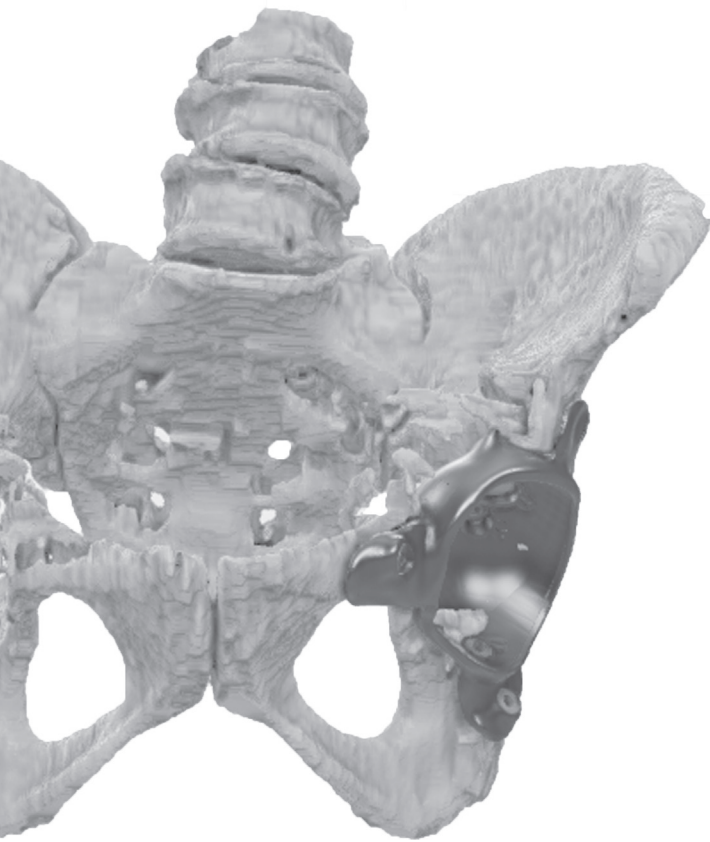
Post-op xrays

Postoperative course simple, with partial support protected by a walker for 4 weeks then total support
